DEPARTMENT OF TRANSPORTATION**DIVISION OF ENGINEERING SERVICES**

Office of Structural Materials

Quality Assurance and Source Inspection

Contract #: 04-0120F4Cty: SF/ALA Rte: 80 PM: 13.2/13.9File #: 82.28**WELDING INSPECTION REPORT****Resident Engineer:** Siegenthaler, Peter**Address:** 333 Burma Road**City:** Oakland, CA 94607**Report No:** WIR-016871**Date Inspected:** 14-Sep-2010**Project Name:** SAS Superstructure**OSM Arrival Time:** 500**Prime Contractor:** American Bridge/Fluor Enterprises, a JV**OSM Departure Time:** 1330**Contractor:** Westmont Industries**Location:** Santa Fe Springs, CA.**CWI Name:** R. Rodriguez, R. Dominguez**CWI Present:** Yes No**Inspected CWI report:** Yes No N/A**Rod Oven in Use:** Yes No N/A**Electrode to specification:** Yes No N/A**Weld Procedures Followed:** Yes No N/A**Qualified Welders:** Yes No N/A**Verified Joint Fit-up:** Yes No N/A**Approved Drawings:** Yes No N/A**Approved WPS:** Yes No N/A**Delayed / Cancelled:** Yes No N/A**Bridge No:** 34-0006**Component:** Travelers**Summary of Items Observed:**

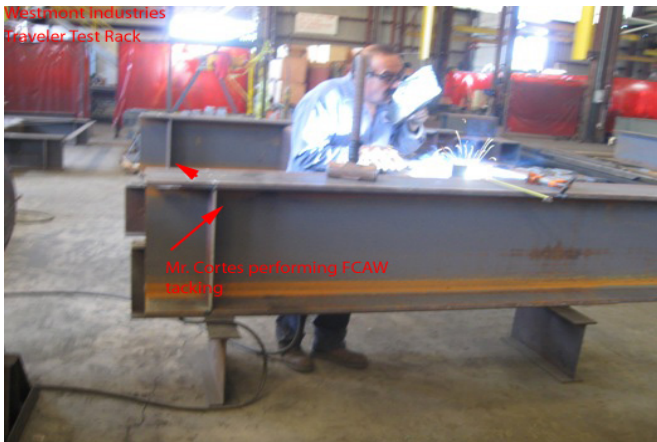
The QA Inspector observed that the above mentioned activities continued throughout the shift and appeared to be in compliance with the contract requirements.

See attached picture below.
